FRENCH RIVER BASIN  
LEICESTER, MASSACHUSETTS

STILES RESERVOIR DAM  
MA 00983

PHASE I INSPECTION REPORT  
NATIONAL DAM INSPECTION PROGRAM

APRIL 1979

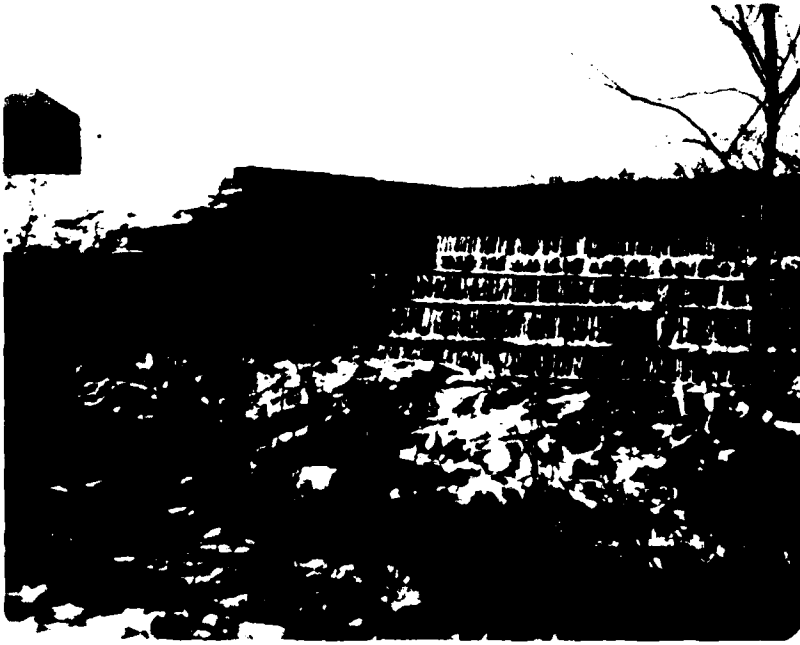
- d. Visual Observations. The spillway appears in good condition except for the leak within the south abutment. The training walls have been repaired in the past and consist of concrete and mortared stone masonry. There is a concrete cap on top of the walls. Some cracks at the joints of the stone wall were noted.

NO. 1 VIEW OF SPILLWAY FROM DOWNSTREAM AREA
